National Property Inspections

**Mountain Vista Unitarian Universalist Congregation, 3235 W Orange Grove Road, Tucson, AZ,
85741**

GENERAL INFORMATION

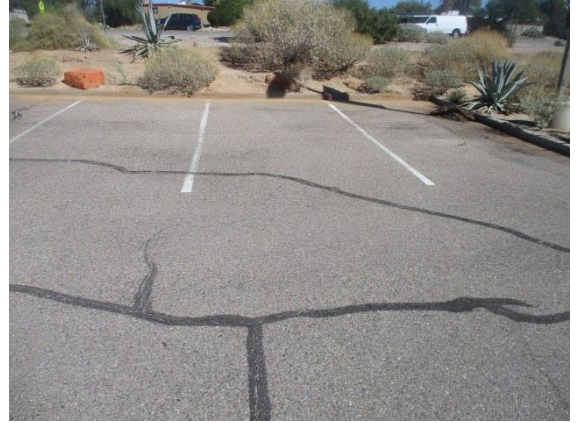
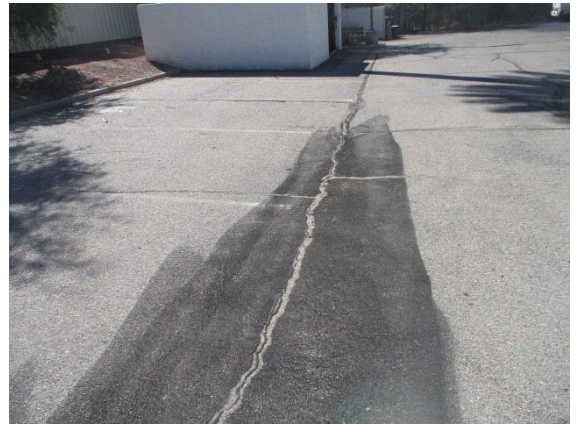
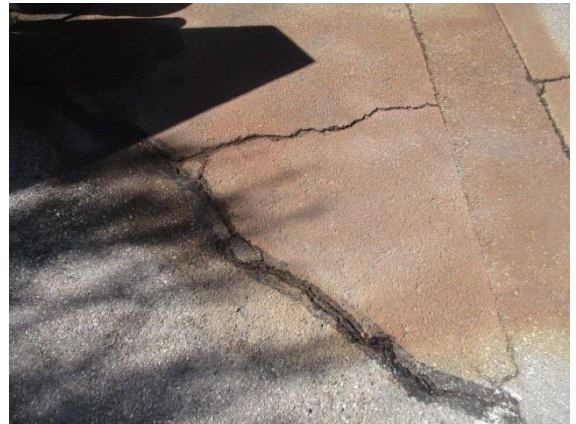
The asphalt parking and driveway areas have a somewhat rough surface. They are past due to be coated and cracks sealed. Coating and sealing slows the rate of deterioration of the asphalt. The parking stripes are faded, should be repainted.

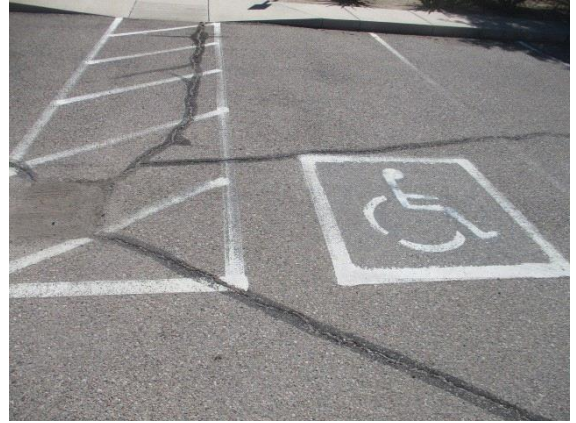
Parking Lot / Driveways: Parking Stripes Faded

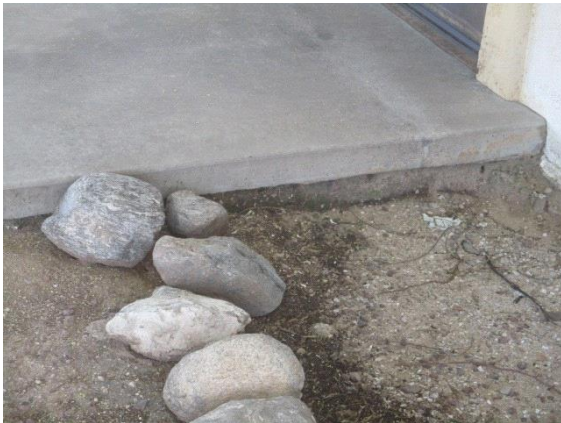
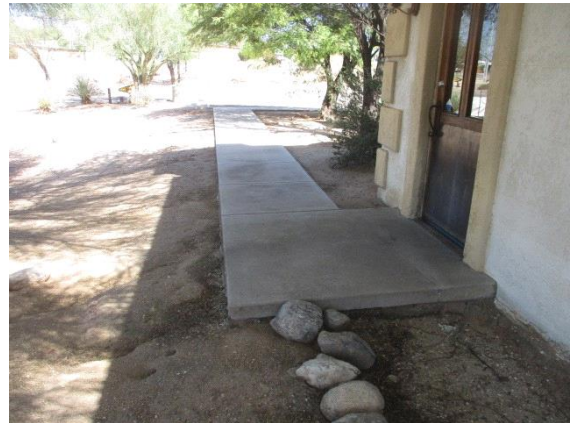
The ground should be built up around the concrete walk at the northwest corner of the building, to give the concrete sufficient support at the edges, and prevent it from cracking.

Flatwork / Sidewalks: Ground Should Be Built Up

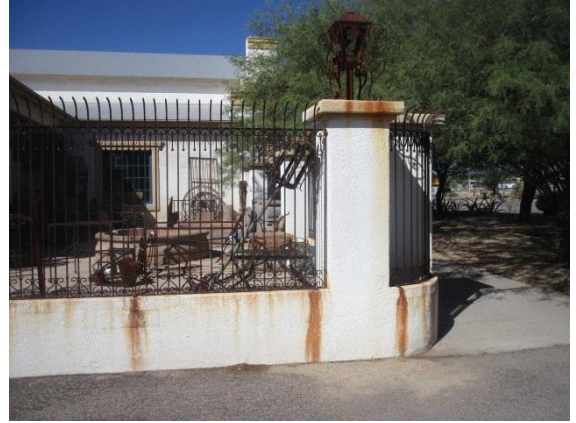
The wrought iron is all rusty, and not sealed. It should be sealed to prevent rust from staining the masonry walls. All the masonry wall in the vicinity of the rusty wrought iron railings is stained. The rear block wall is not painted, and it has graffiti on it, all along the rear and southwest corner.

Fences / Enclosures: Rust Stains

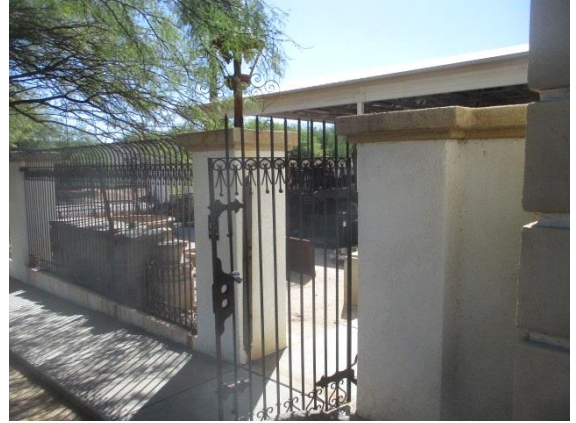
Fences / Enclosures: Graffiti

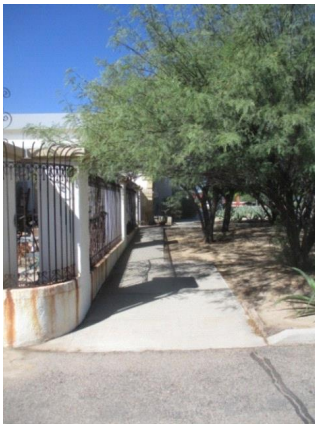
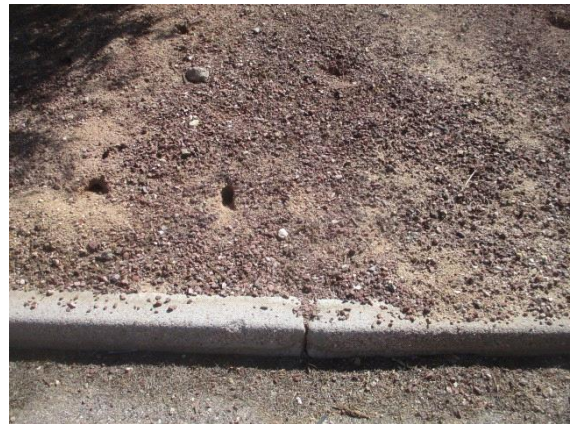
There are a lot of holes in the ground, mostly in the front and east sides, caused by ground squirrels. Most of the trees are severely over grown, especially at the northwest corner of the building, around the exterior covered area, and the southeast corner of the property, near the trash container enclosure. Gravel is thin in most areas.

Landscaping: Holes In Ground

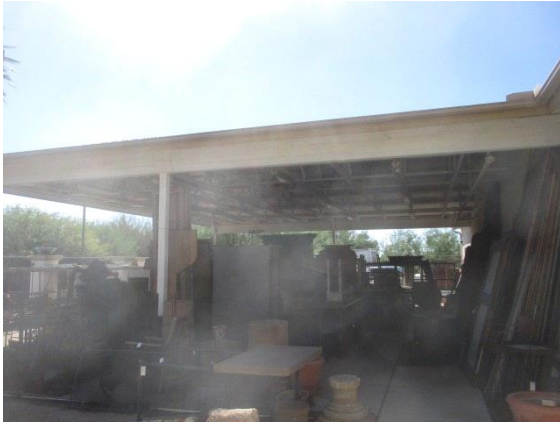
The east facing siding should be painted asap. Paint protects the wood from deterioration. Only about 4 of the ceiling lights turned on, out of about 16 fixtures.

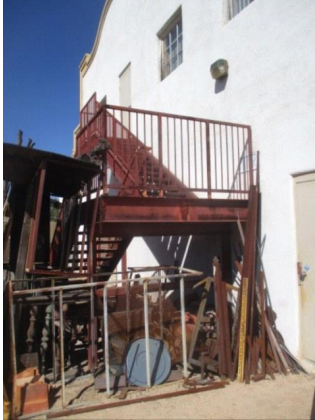
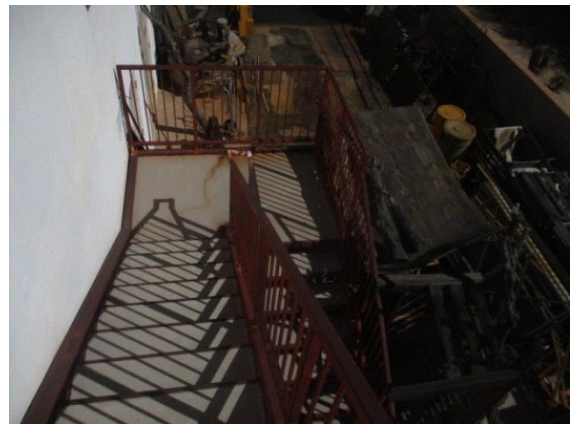
The stairs are rusty. Rust spots should be sanded and primed.

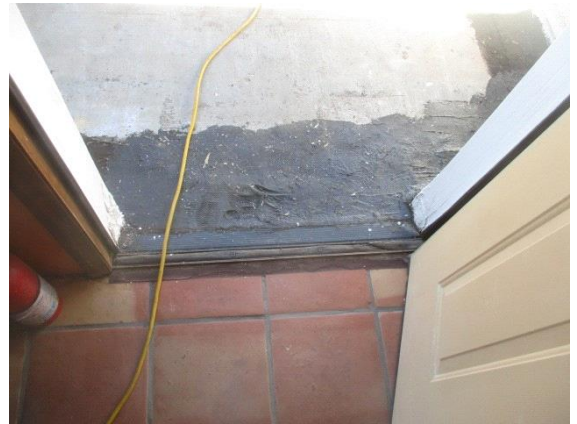
There has been an on and off roof leak at the door to the west flat roof area. That section of roof needs patching and coating. The majority of the roof is corrugated metal roofing, which should last 50 years, with minimal maintenance. RoofSavers, 520-884-1288, RoofSmart, 520-797-5656 and RoofFixers, 520-818-8485, all do free inspections and estimates. I recommend calling one of them for additional evaluation and repair.

Roofing: Roof Leak At Door

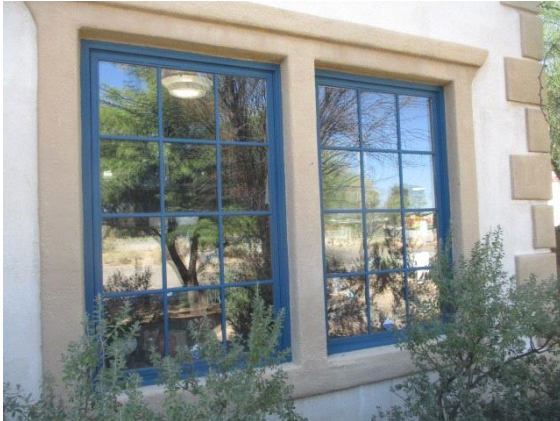
Paint has peeled off the south facing window frames. The wood has weathered/deteriorated. They should be painted immediately, to protect the wood from further deterioration.

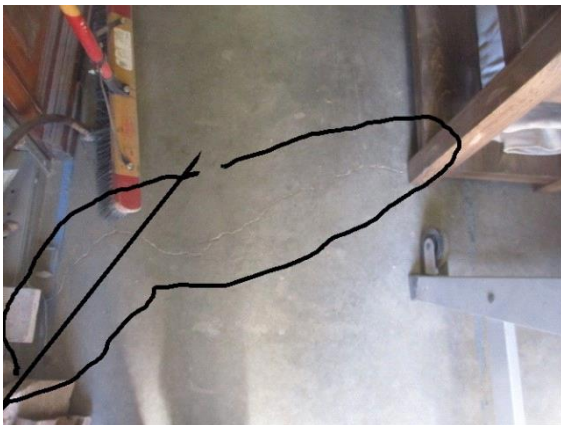
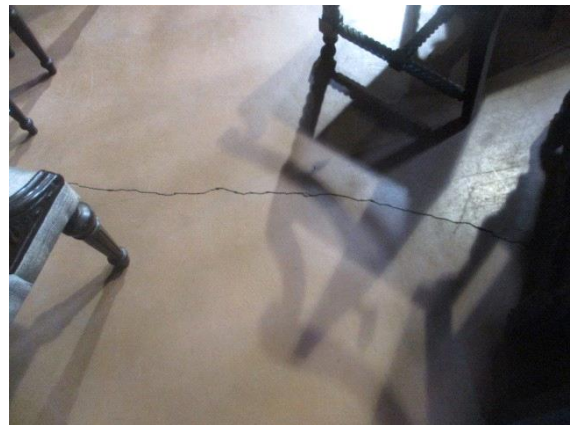
There are few floor/slab cracks.

Floor / Slab: Crack

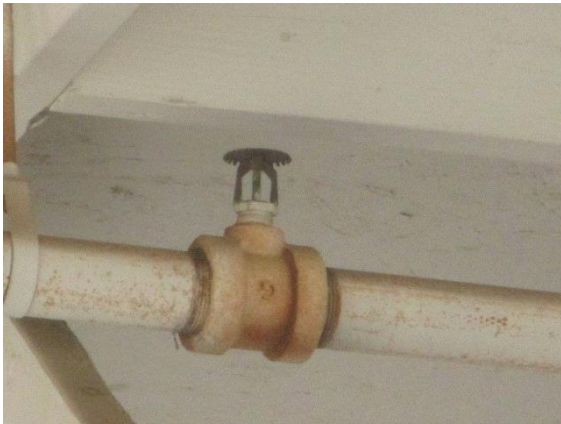
Gas pipes at the gas package units are rusty. They should be sanded, primed and painted.

Plumbing: Rusty

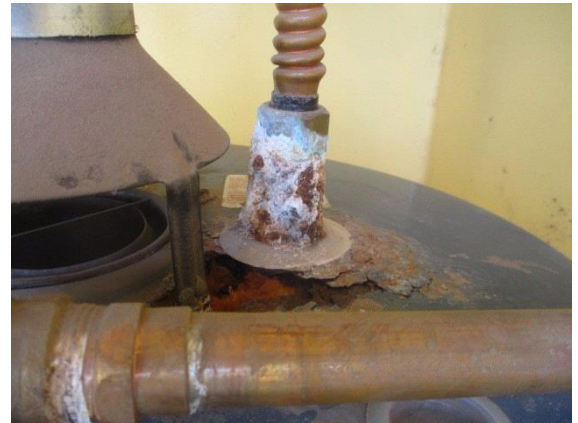
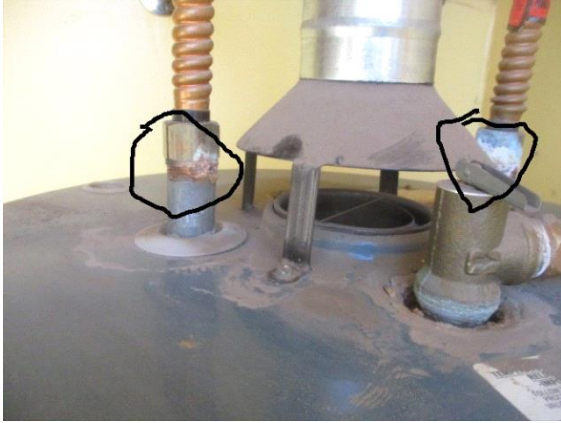
There is deterioration at both the pipe connections on the top of the hot water heater.

Water Heater: Deterioration

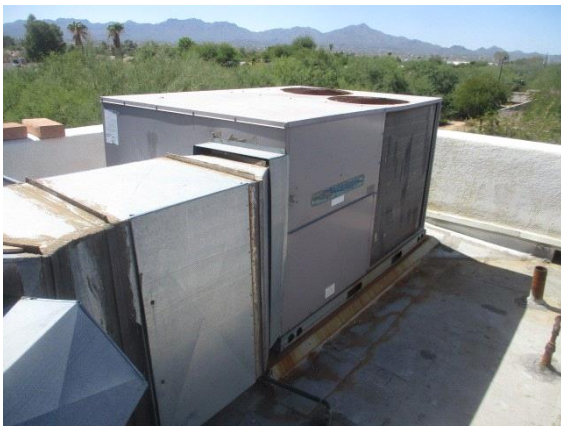
Heating 1st Floor West:

The gas pipe at the unit is rusty. The pipe should be sanded, primed and painted to protect it from further deterioration.

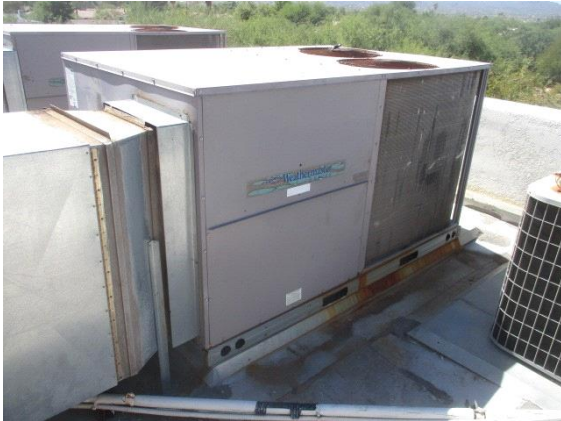
Heating 1st Floor East:

The gas pipe at the unit is rusty. The pipe should be sanded, primed and painted to protect it from further deterioration.

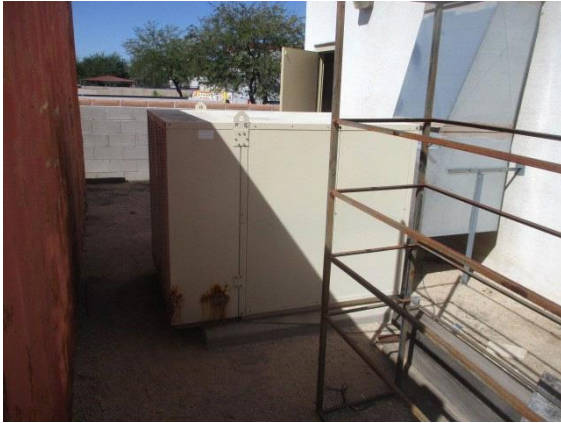
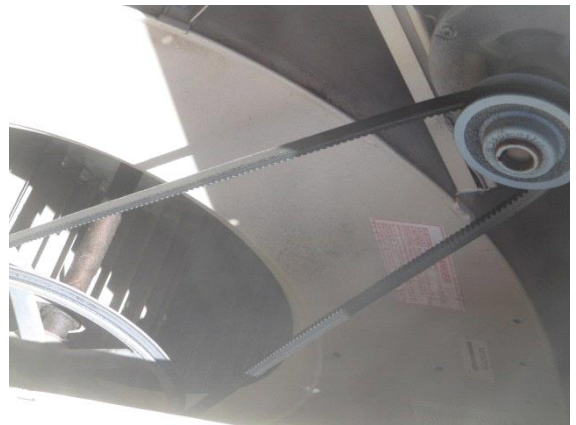
The evaporative cooler is in good working order, but it has rust spots. Rust should be sanded and primed, before further deterioration causes a leak.

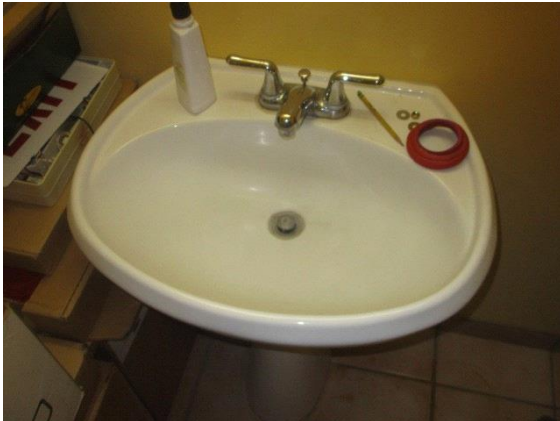
The toilet is out of commission. There is a leak between the tank and bowl. The seller ordered the parts needed to fix it.

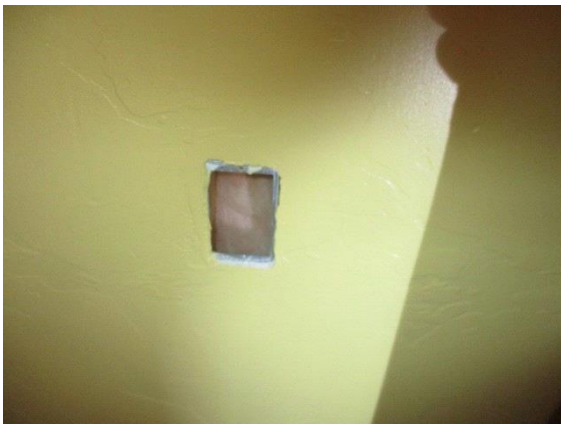
There are scratches in a section of wall, and a blank plate to cover an empty electric box is missing.

Upstairs Bathroom: Missing Plate

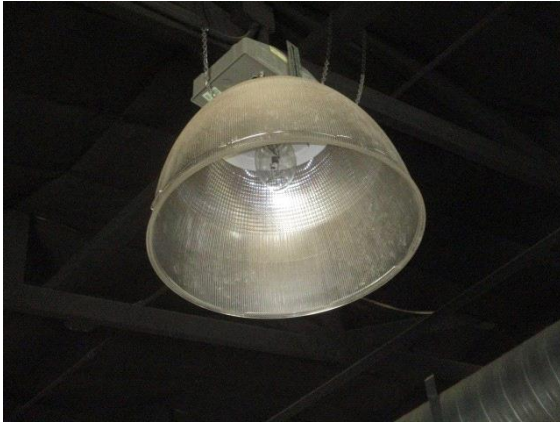
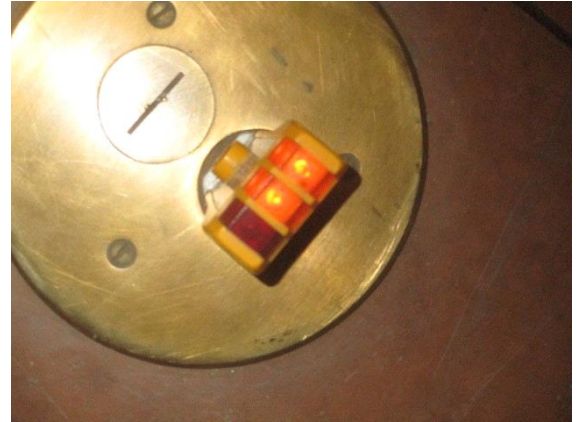
There are about eight ceiling lights out.
There is a floor/slab crack in the northeast section of the room. I couldn't tell how long it is due to all the items on display. The floor has not been sealed since the building was new.

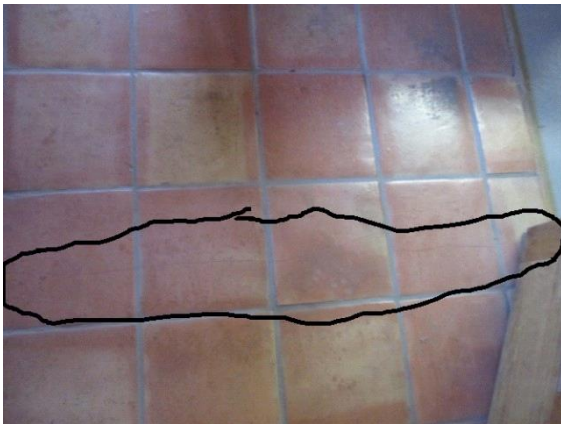
There are at least six cracked saltillo tiles.
The ceilings are not finished, trusses are exposed.

2nd Floor Storage & Office: Cracked Floor Tiles

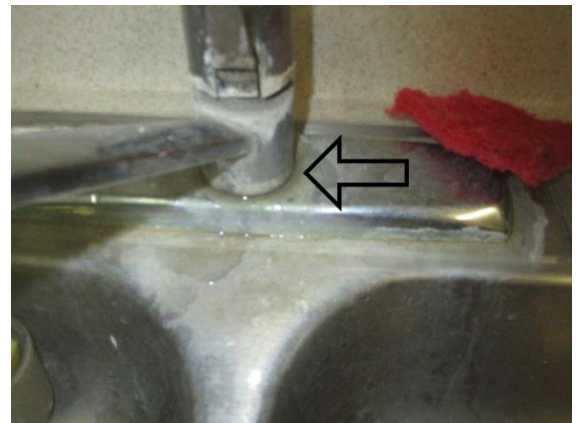
Paint is worn off the floor. It should be repainted.
There is a leak at the base of the faucet spout.

Break Room: Leak

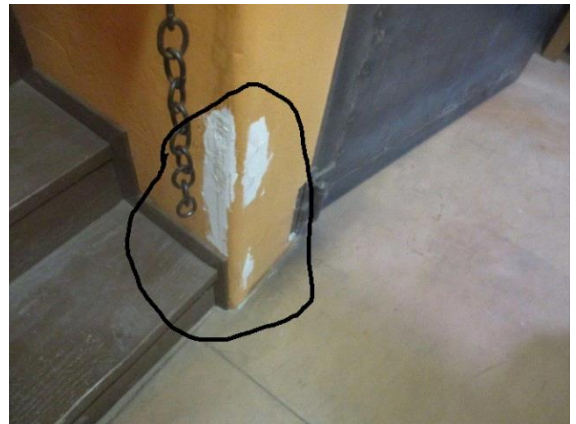
Stairs / Railings: Needs Paint

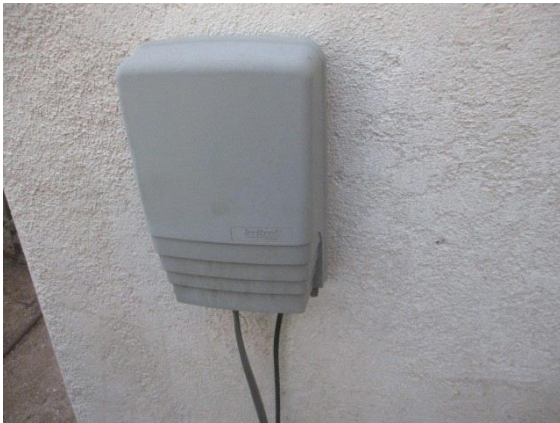
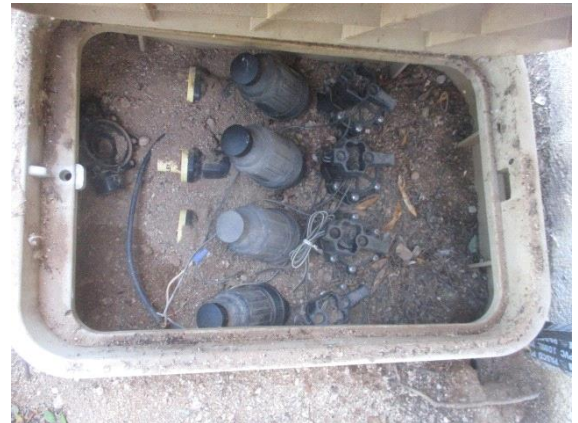
The seller has not run the irrigation system for many years. He tried to turn it on, but nothing happened. Two of the four valves' wiring are not connected. Also, some tubing is run along the surface. All tubing should be buried, to protect it from getting damaged.

When I returned on Thursday, the seller said he got two of the zones, the ones with the wiring connected, to run, but that there were leaks at the valves.
