National Property Inspections

**Mountain Vista Unitarian Universalist Congregation, 3235 W Orange Grove Road, Tucson, AZ,
85741**

GENERAL INFORMATION

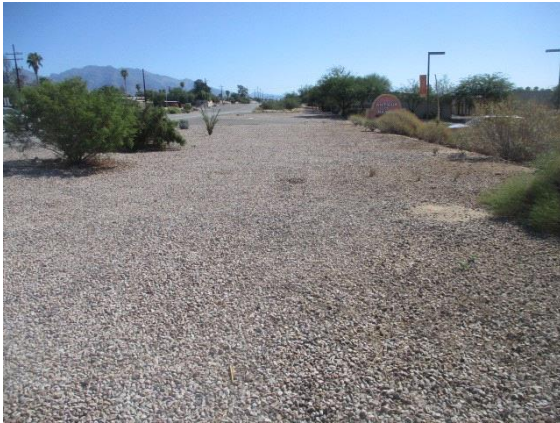
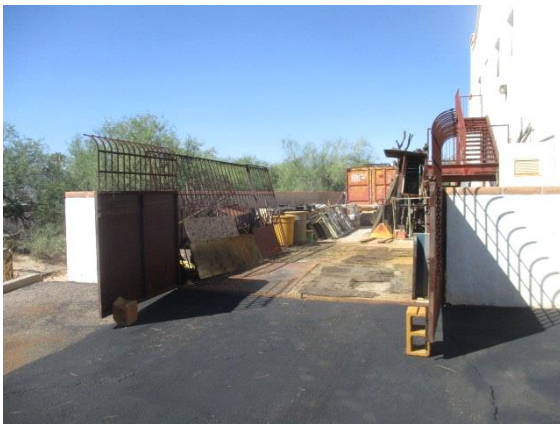
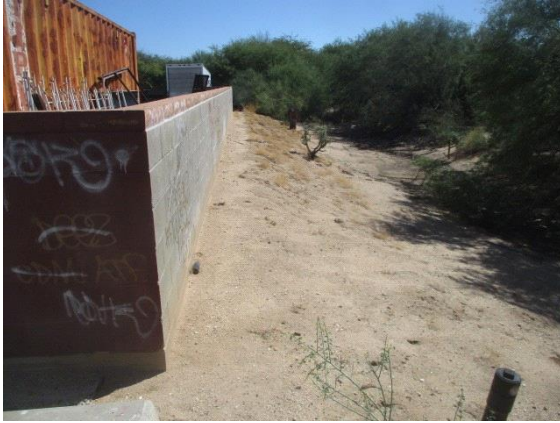
Most of the front and west side drain to just west of the southeast corner of the property. The area west of the building drains to the neighbors property. Dirt has washed on to the neighboring property. Lack of a gutter has resulted in rain poring over the west side of the building to wash away dirt. The dirt at the building should be the high point, then slope down from there. Some earthwork is needed to adjust the slope. Then heavy gravel should be applied on top of the dirt to prevent erosion.

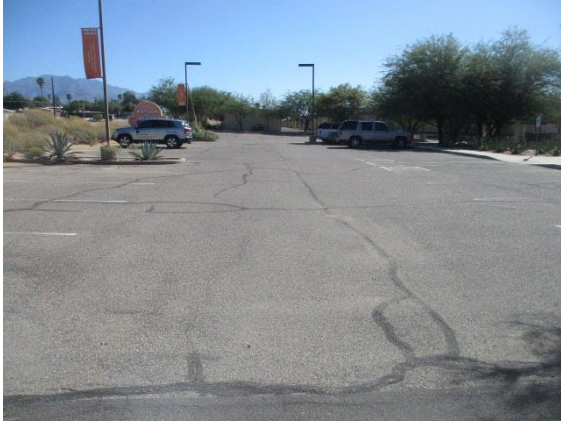
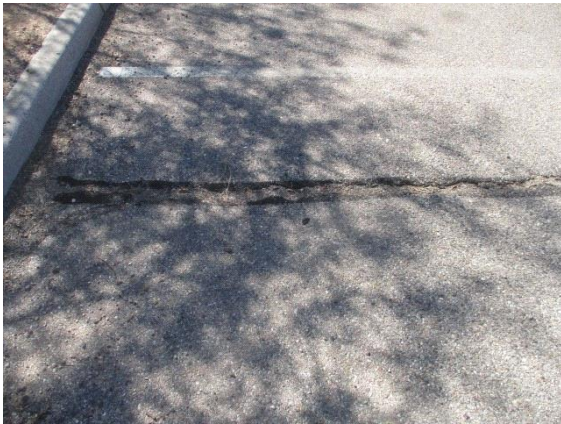
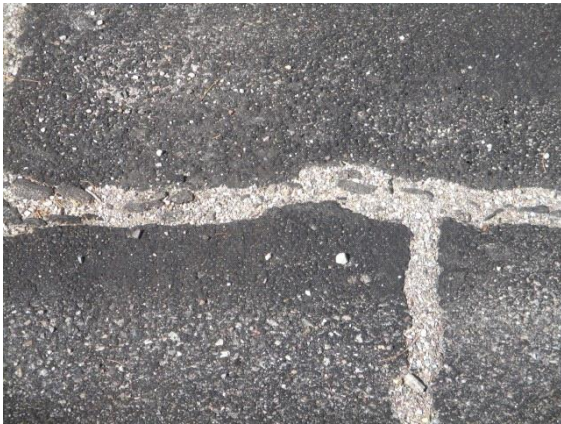
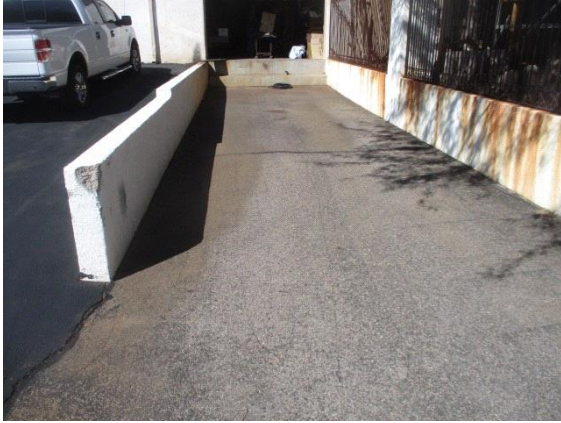
The asphalt parking and driveway areas have a somewhat rough surface. They are past due to be coated and cracks sealed. Coating and sealing slows the rate of deterioration of the asphalt. The parking stripes are faded, should be repainted.

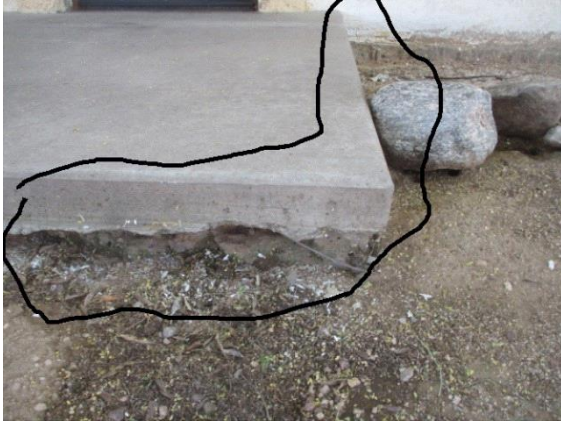
The ground should be built up around the concrete walk at the northwest corner of the building, to give the concrete sufficient support at the edges, and prevent it from cracking.

Flatwork / Sidewalks: Ground Should Be Built Up

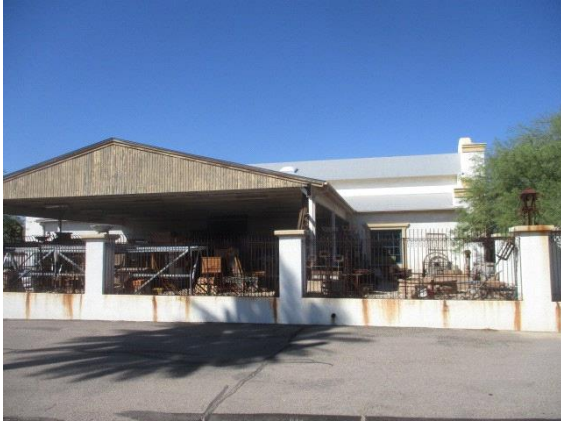
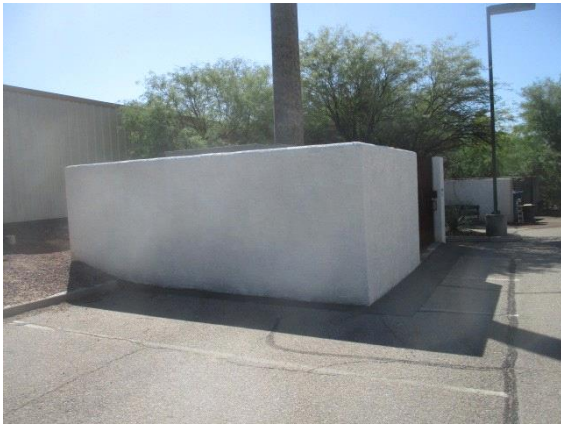
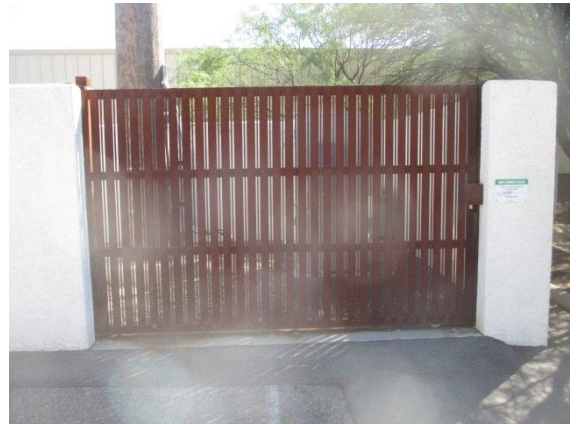
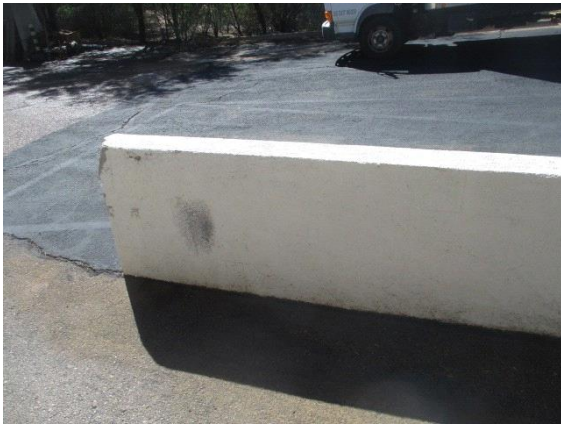
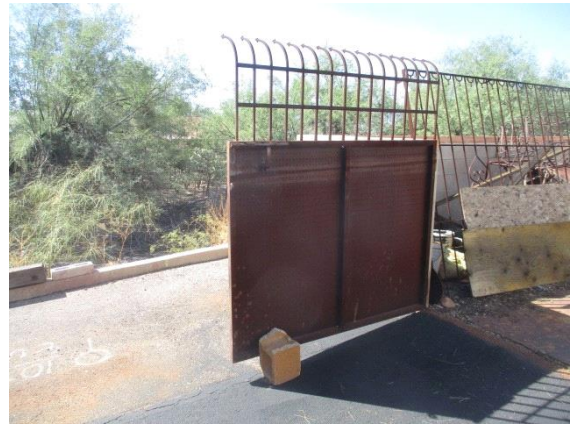
The wrought iron is all rusty, and not sealed. It should be sealed to prevent rust from staining the masonry walls. All the masonry wall in the vicinity of the rusty wrought iron railings is stained. The rear block wall is not painted, and it has graffiti on it, all along the rear and southwest corner.

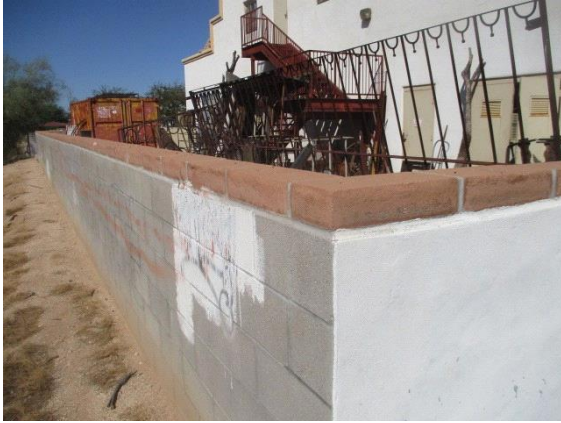
Fences / Enclosures: Graffiti

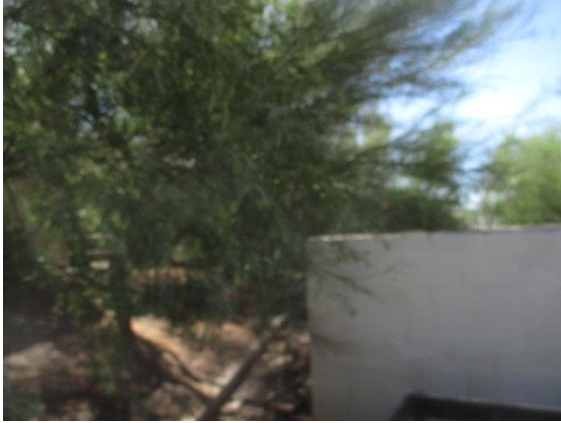
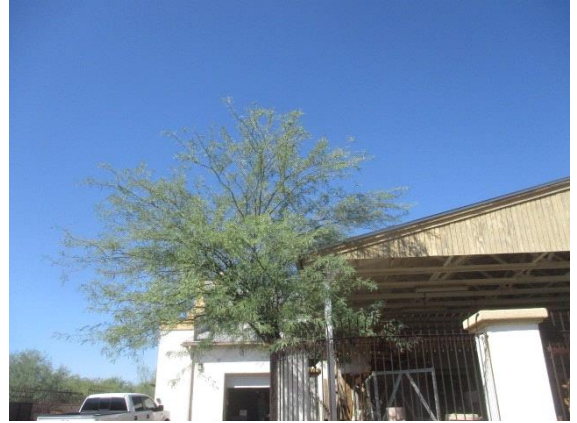
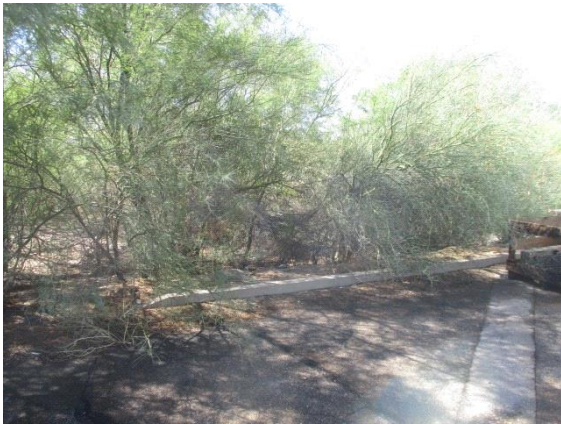
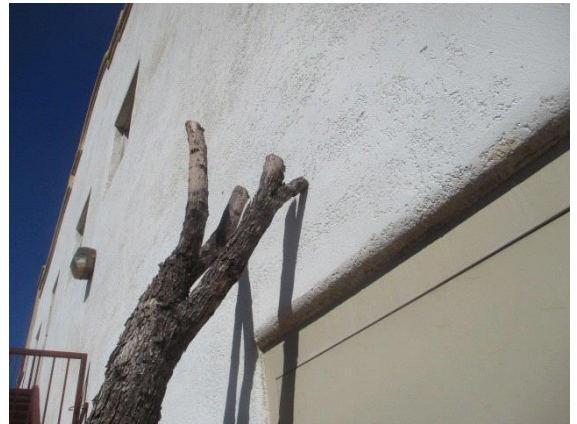
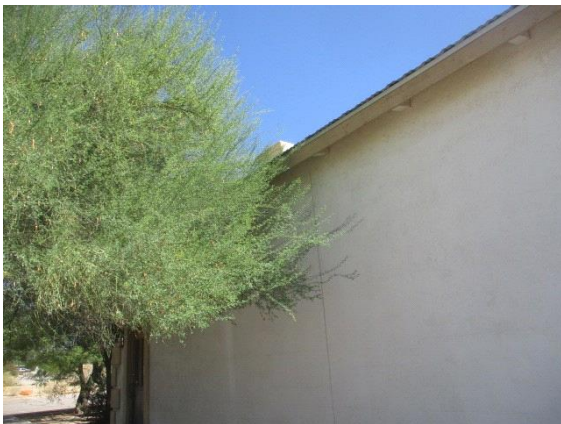
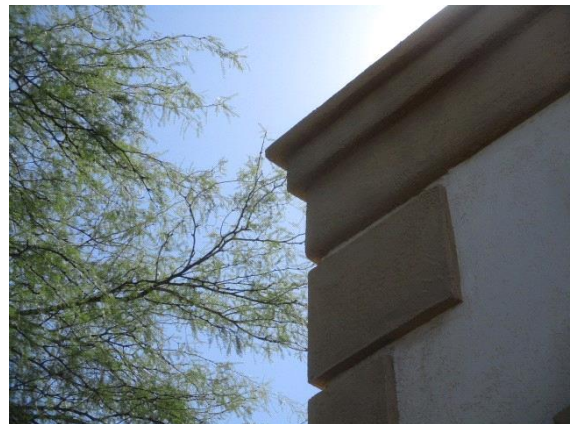
There are a lot of holes in the ground, mostly in the front and east sides, caused by ground squirrels. Most of the trees are severely over grown, especially at the northwest corner of the building, around the exterior covered area, and the southeast corner of the property, near the trash container enclosure. Gravel is thin in most areas.

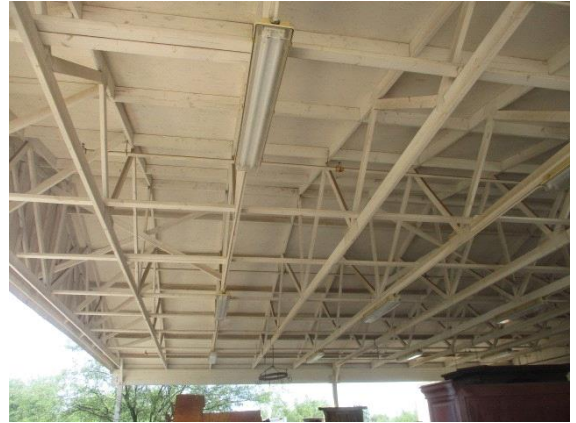
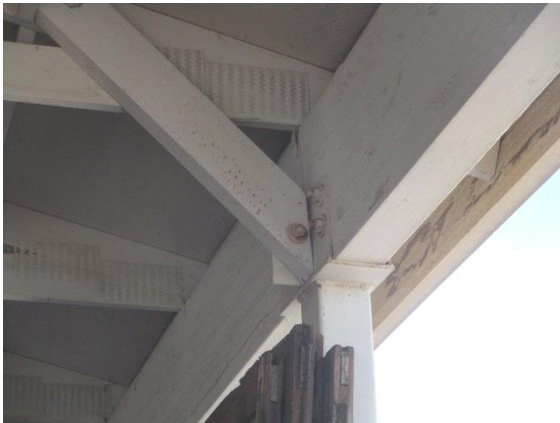
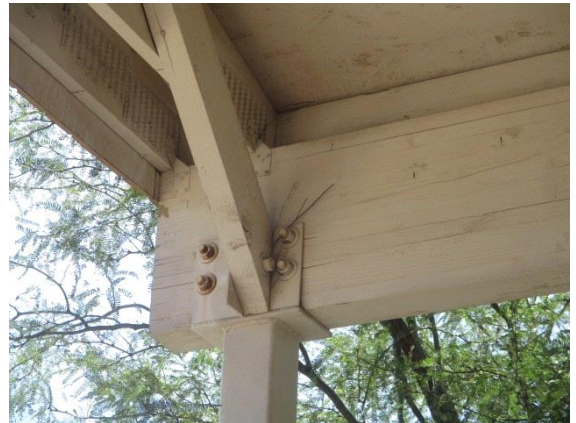
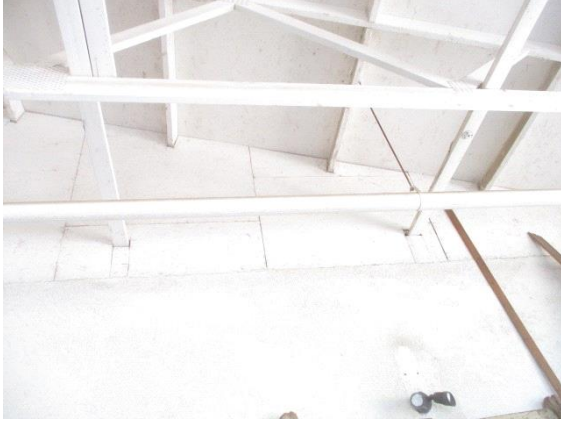
The east facing siding should be painted asap. Paint protects the wood from deterioration. Only about 4 of the ceiling lights turned on, out of about 16 fixtures.

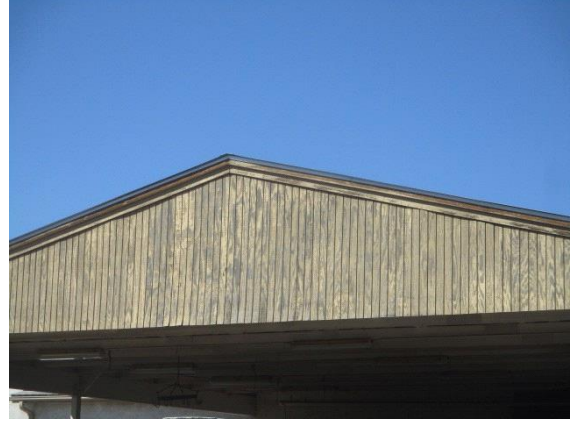
Covered Area: Needs Paint

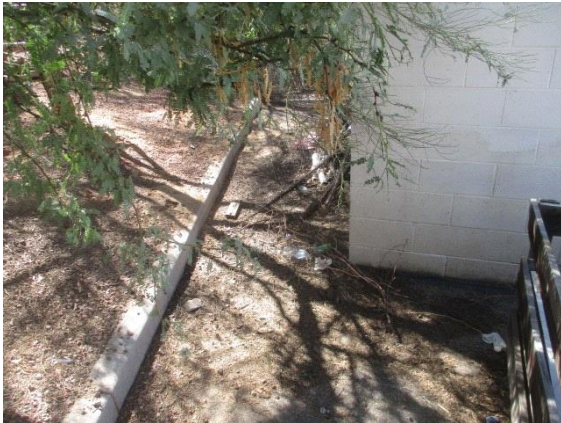
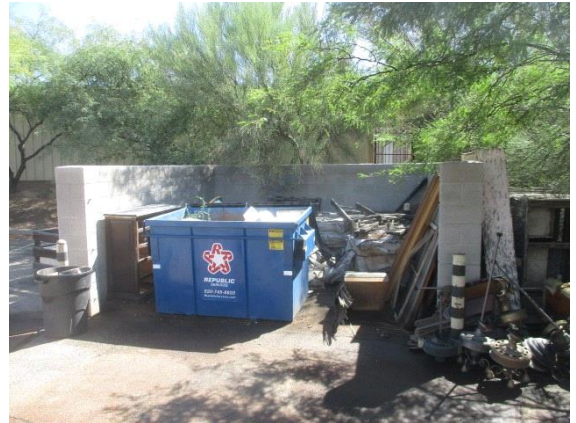
There is a lot of debris from trees, and uncollected trash from the business, in and around the trash container enclosure at the southeast corner of the property.

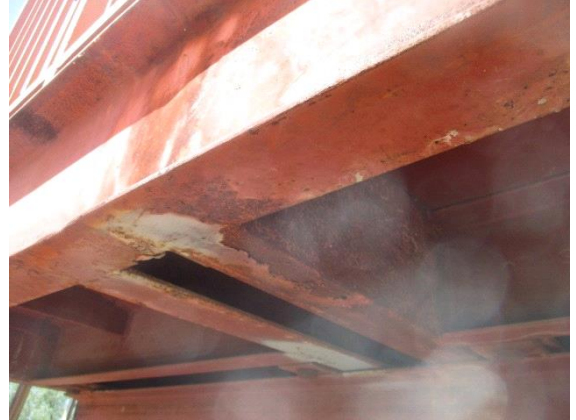
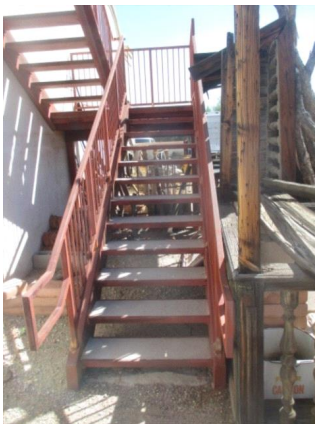
The stairs are rusty. Rust spots should be sanded and primed.

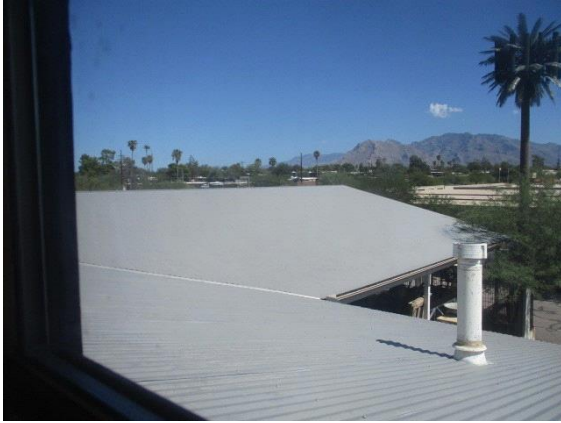
Roofing: Southeast Roof

There has been an on and off roof leak at the door to the west flat roof area. That section of roof needs patching and coating. The majority of the roof is corrugated metal roofing, which should last 50 years, with minimal maintenance. RoofSavers, 520-884-1288, RoofSmart, 520-797-5656 and RoofFixers, 520-818-8485, all do free inspections and estimates. I recommend calling one of them for additional evaluation and repair.

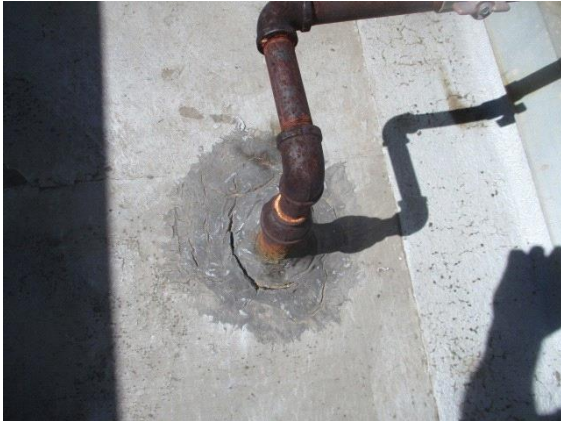
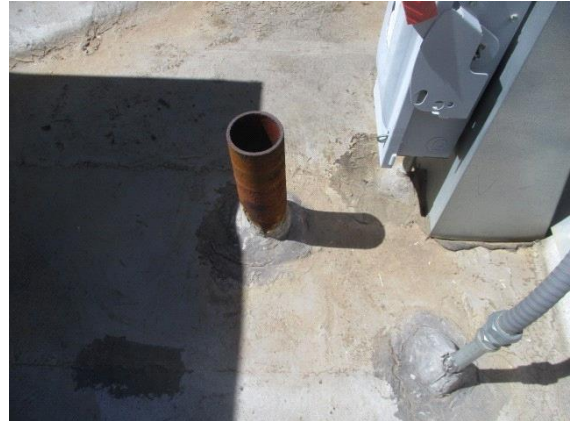
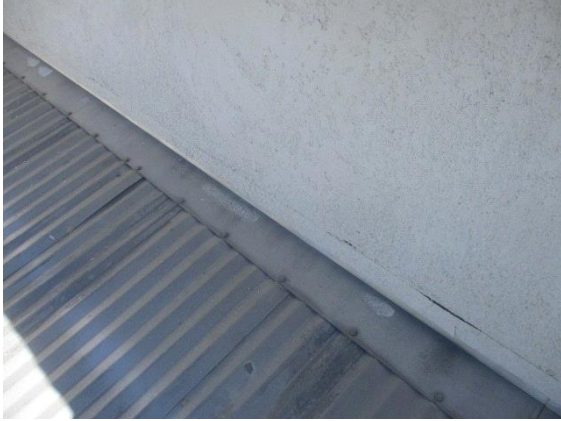
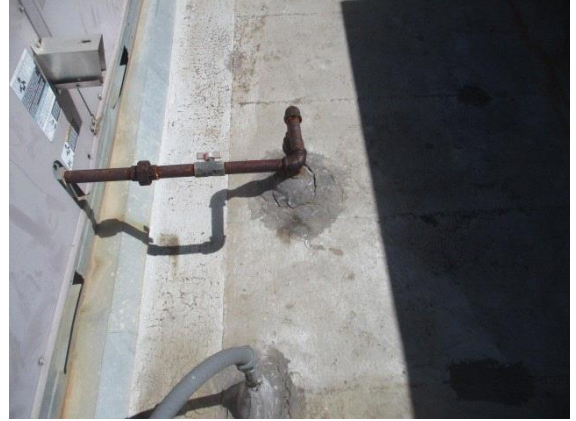
All roof penetrations in the flat roof area need sealing.

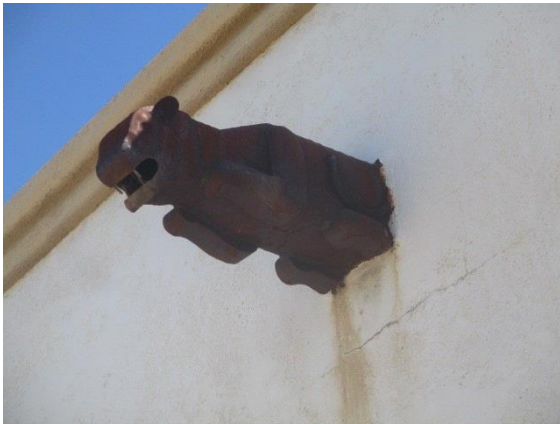
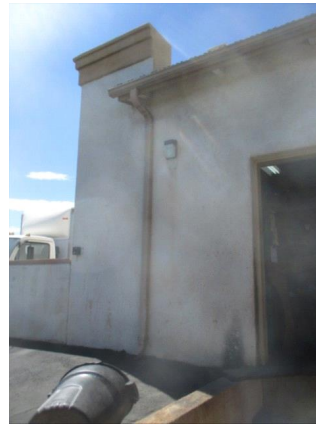
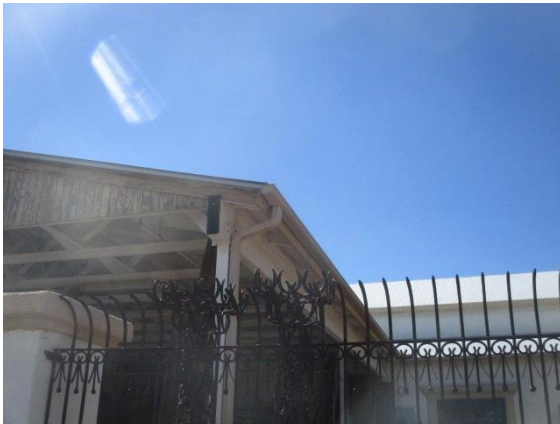
Gutters along the west side of the building would have prevented the erosion in that area. The existing gutters are at the exterior covered area and the east side. There are two scuppers/roof drains at the flat roof area.

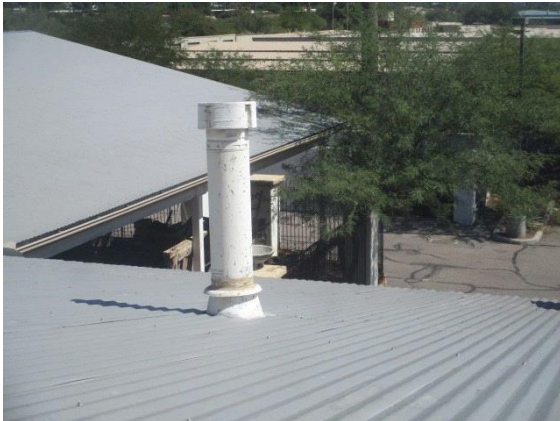
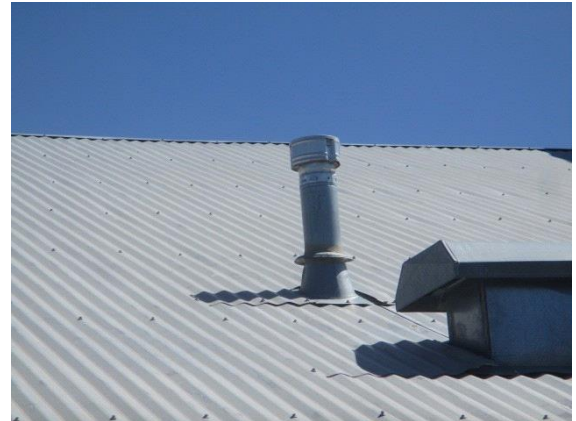
Flue not inspected. Annual cleaning is recommended.

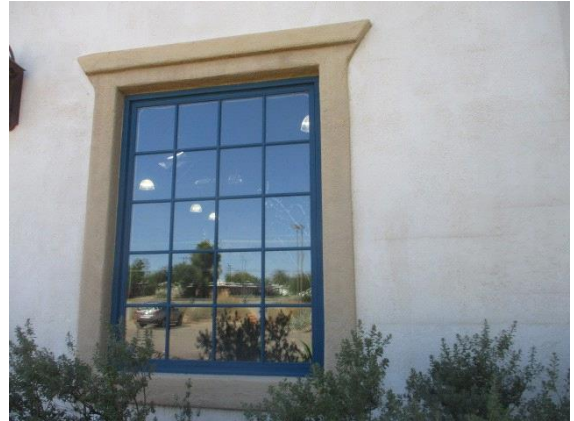
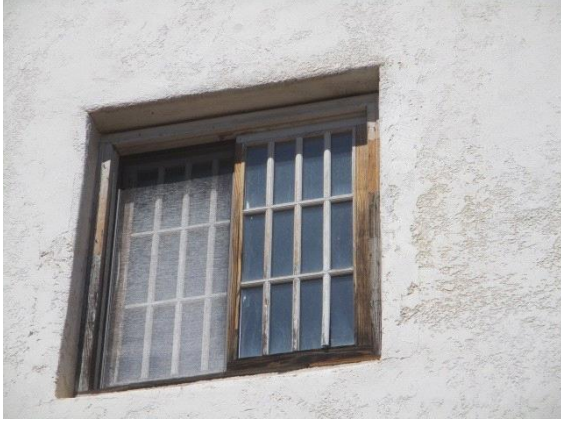
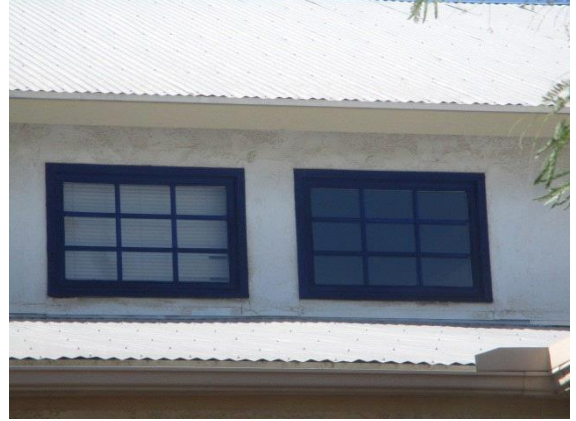
Paint has peeled off the south facing window frames. The wood has weathered/deteriorated. They should be painted immediately, to protect the wood from further deterioration.

Windows: Needs Paint

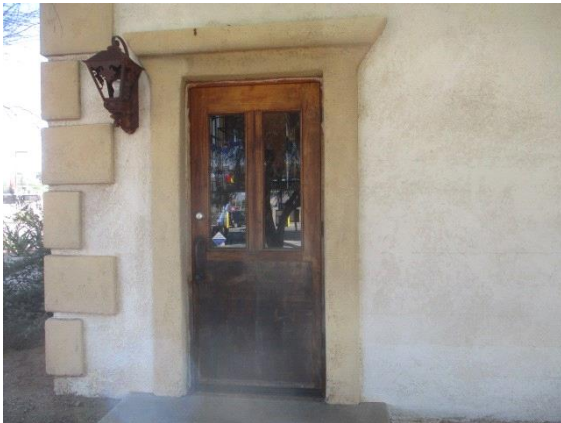
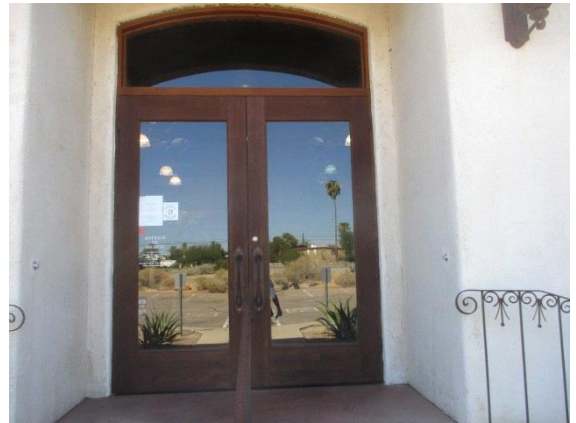
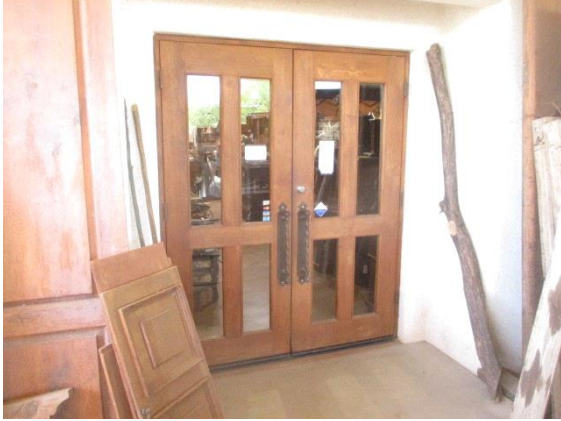
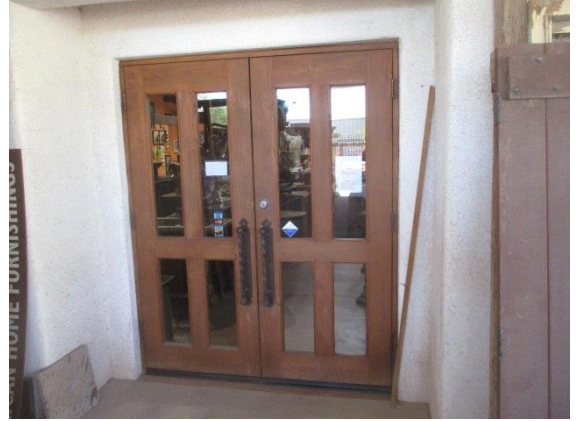
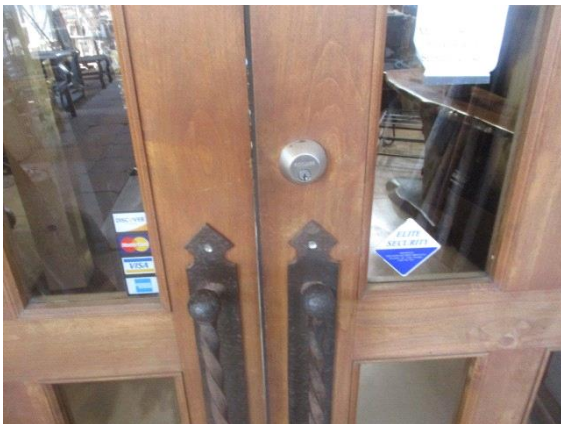
The wood doors are not sealed well. And they need new weather strip, especially at the gap between the double doors.

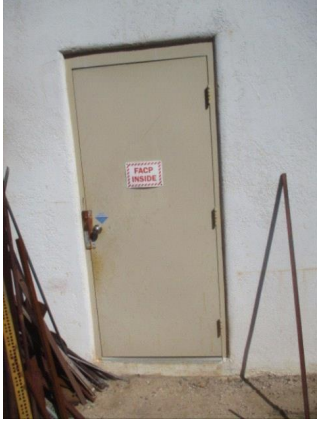
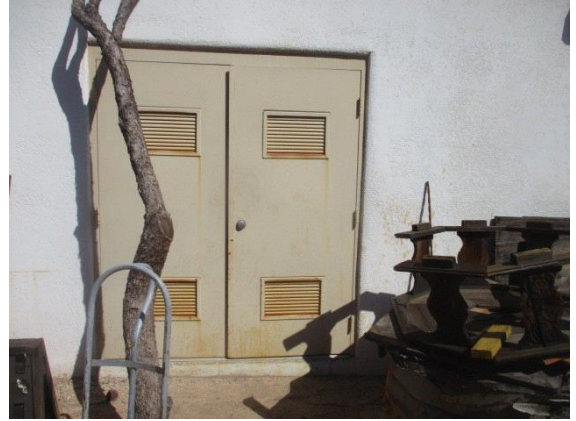
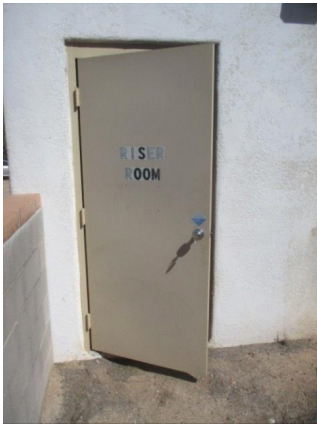
Freight doors all have some rust, and should be repainted. There is no handle, only a deadbolt, at the double doors. A handle would make it easier to open and close the doors.

Freight Doors: No Handle, Only Deadbolt

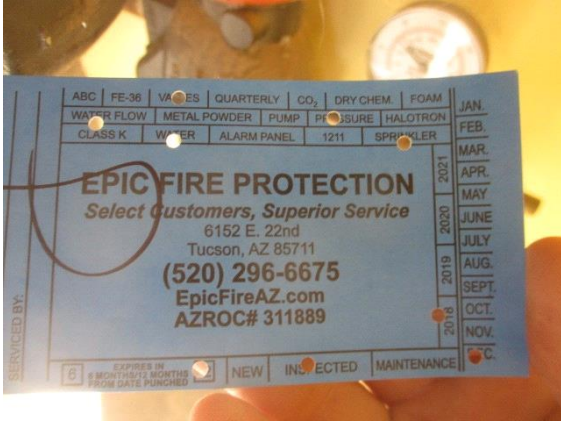
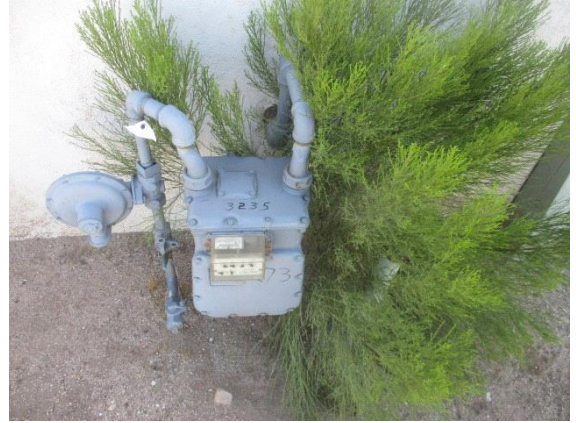
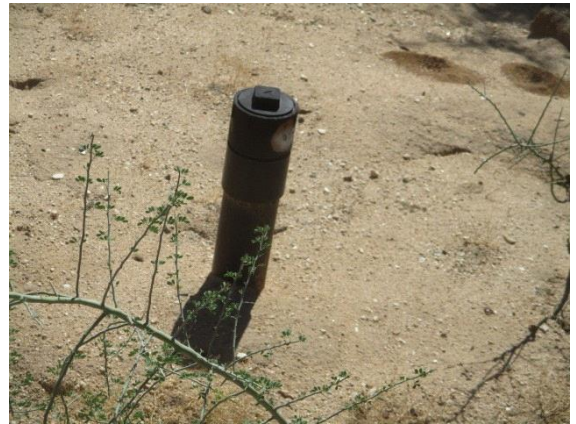
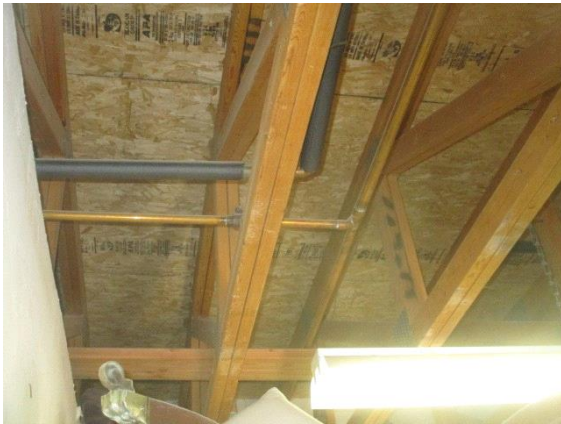
Gas pipes at the gas package units are rusty. They should be sanded, primed and painted.

Fire sprinkler pipes in the exterior covered area have some rust.

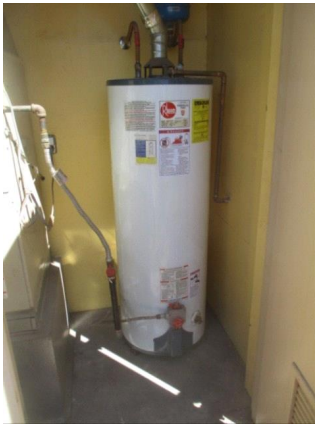
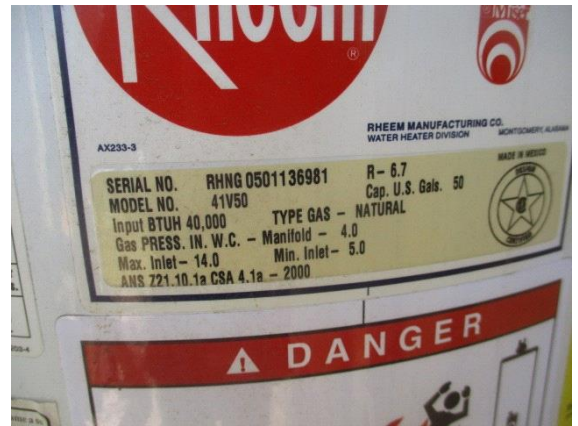
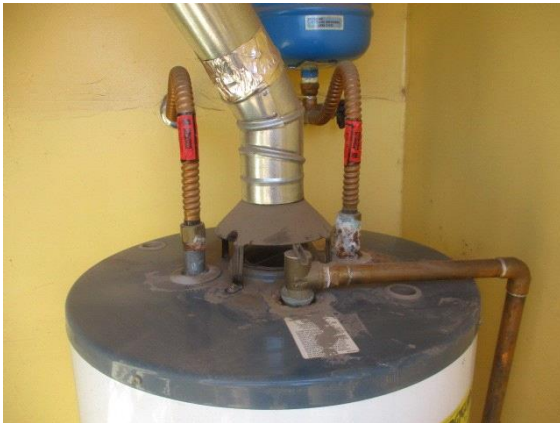
There is deterioration at both the pipe connections on the top of the hot water heater.

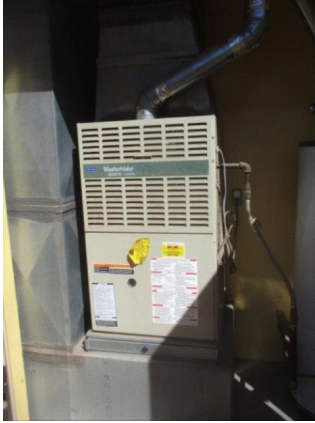
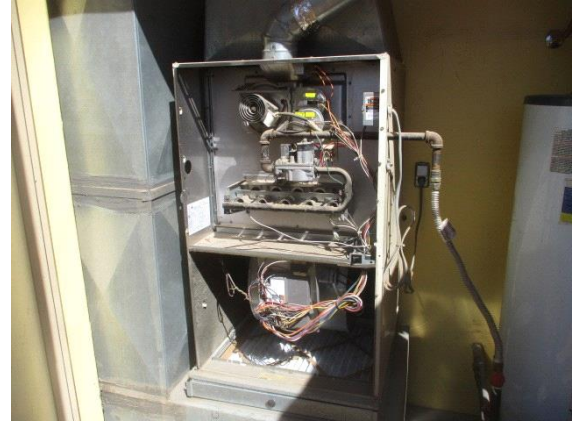
The gas pipe at the unit is rusty. The pipe should be sanded, primed and painted to protect it from further deterioration.

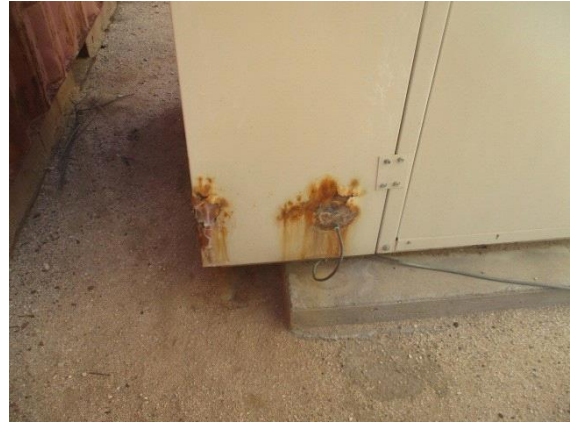
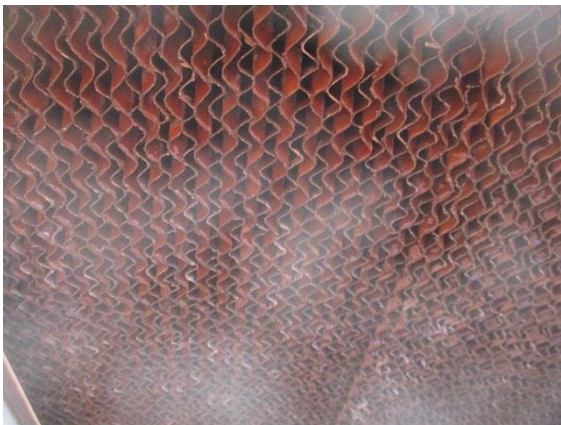
The evaporative cooler is in good working order, but it has rust spots. Rust should be sanded and primed, before further deterioration causes a leak.

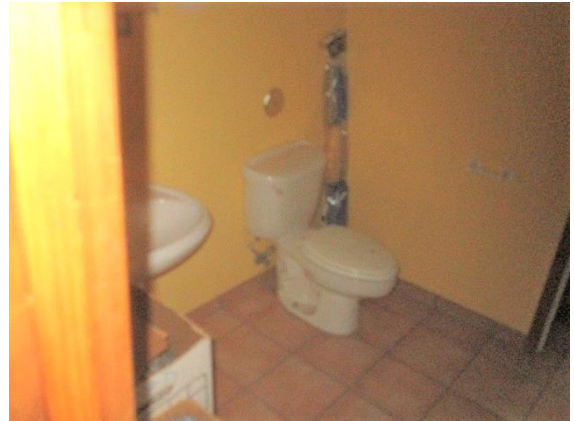
The toilet is out of commission. There is a leak between the tank and bowl. The seller ordered the parts needed to fix it.

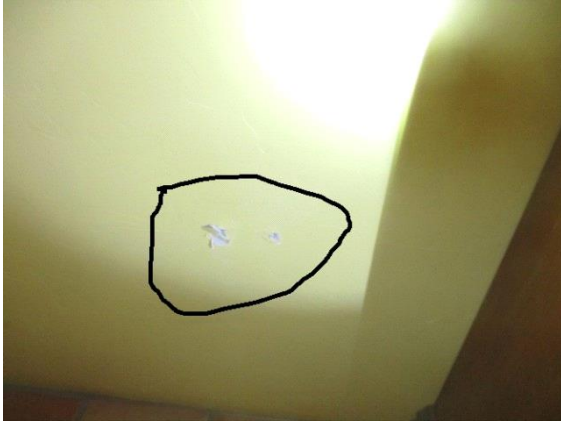
There are scratches in a section of wall, and a blank plate to cover an empty electric box is missing.

Upstairs Bathroom: Scratched Wall

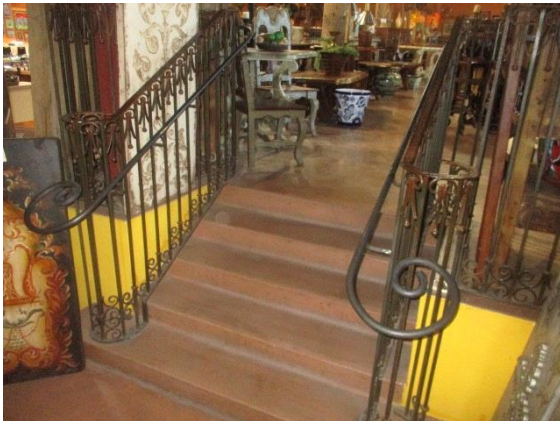
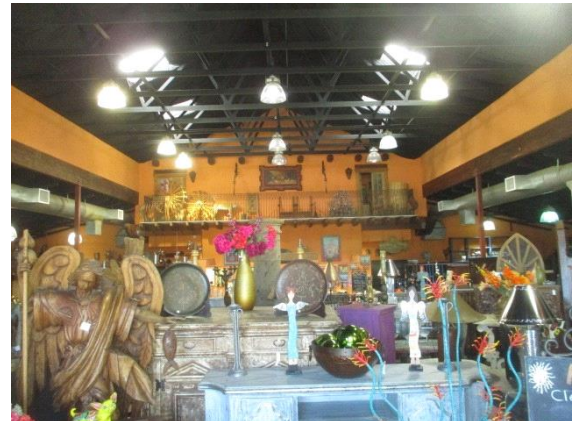
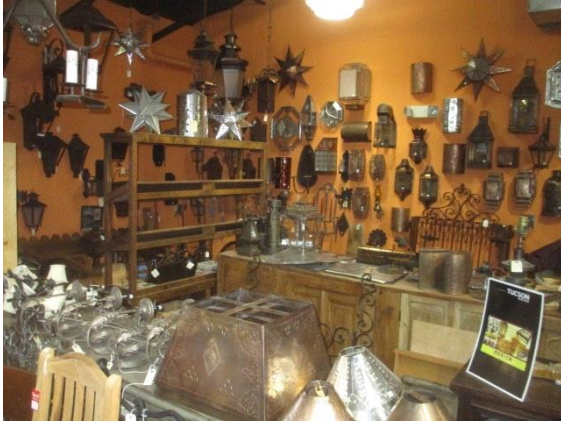
There are about eight ceiling lights out.
There is a floor/slab crack in the northeast section of the room. I couldn't tell how long it is due to all the items on display. The floor has not been sealed since the building was new.

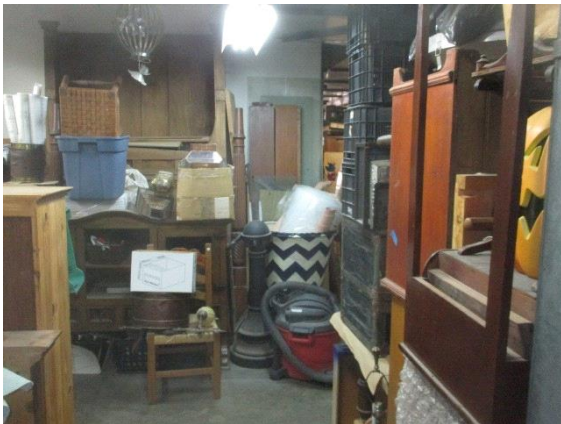
1st Floor Storage & Work Area:

The ceiling trusses are exposed. There is no drywall in the ceiling.
The floor is bare concrete.

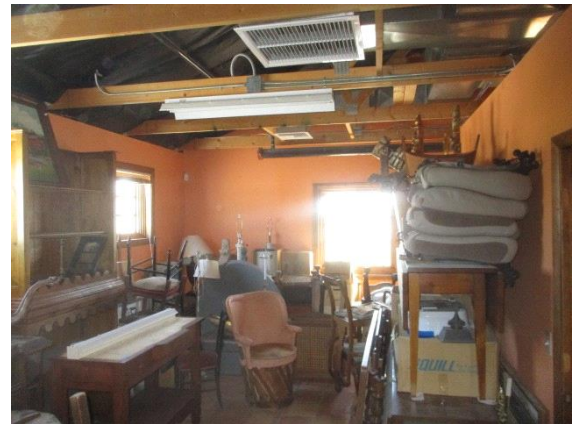
2nd Floor Storage & Office:

There are at least six cracked saltillo tiles.
The ceilings are not finished, trusses are exposed.

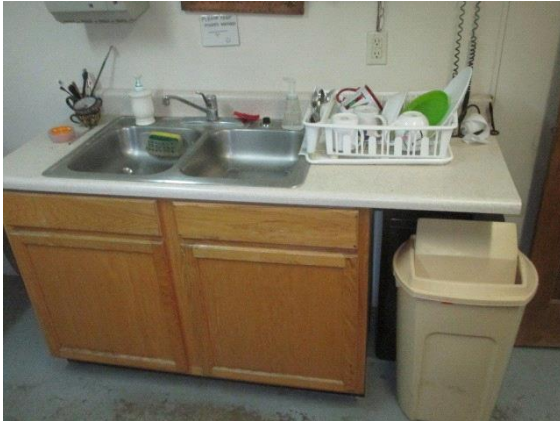
Break Room:

Paint is worn off the floor. It should be repainted.
There is a leak at the base of the faucet spout.
